**Inspection Report**

**Minerals Regulatory Program**

**Mine Name:** The Rockland Mine  
**Operator Name:** Miracle Rock Mining and Research

**Permit number:** M0150040  
**Inspection Date:** April 12, 2007  
**Time:** 9:00-10:45 AM

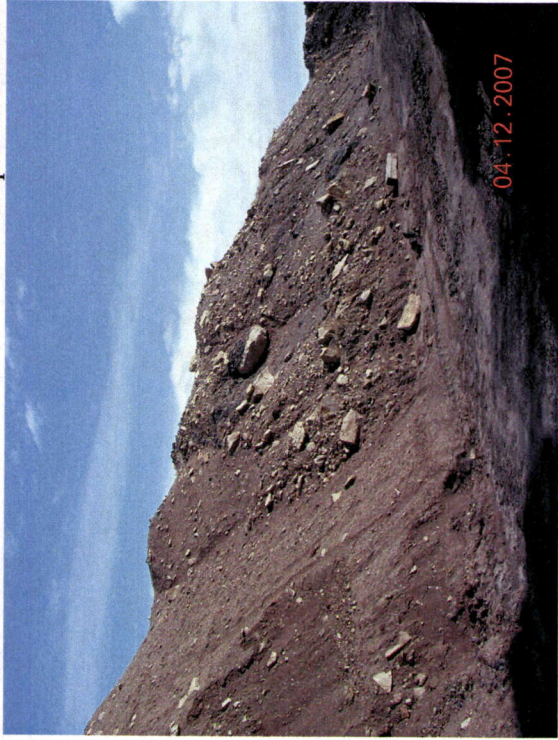
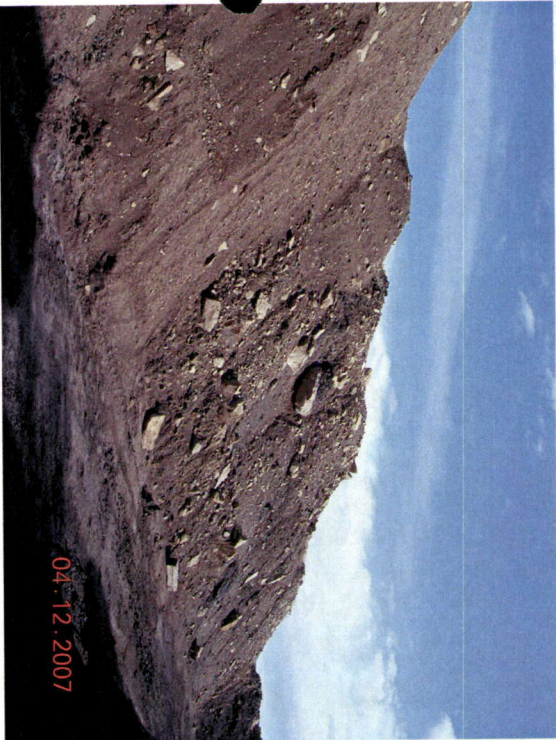
This is mostly an underground mine, and there have been few changes since the last inspection. Various views of the site are in Photos 1 through 4. Surface mining has occurred in the south part of the mine area (Photos 1 and 2) with underground mining elsewhere. Photo 3 shows the newest part of the mine that was developed about three years ago.

**Photo 1. The refuse pile in the surface mining area.**

Photo 1. The refuse pile in the surface mining area.

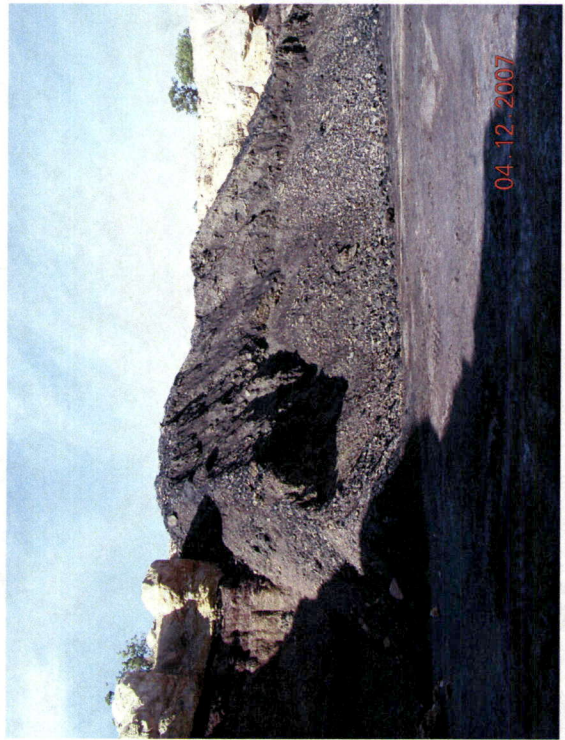
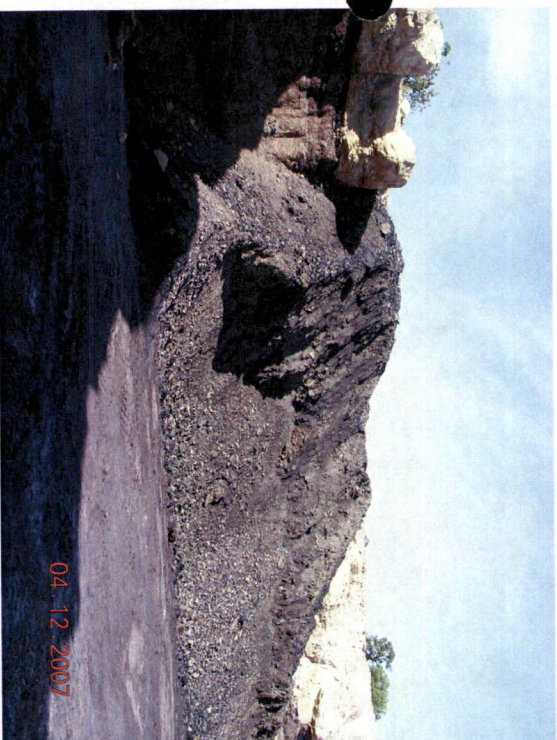
**Photo 2. A product stockpile in the surface mining area.**

Photo 2. A product stockpile in the surface mining area.

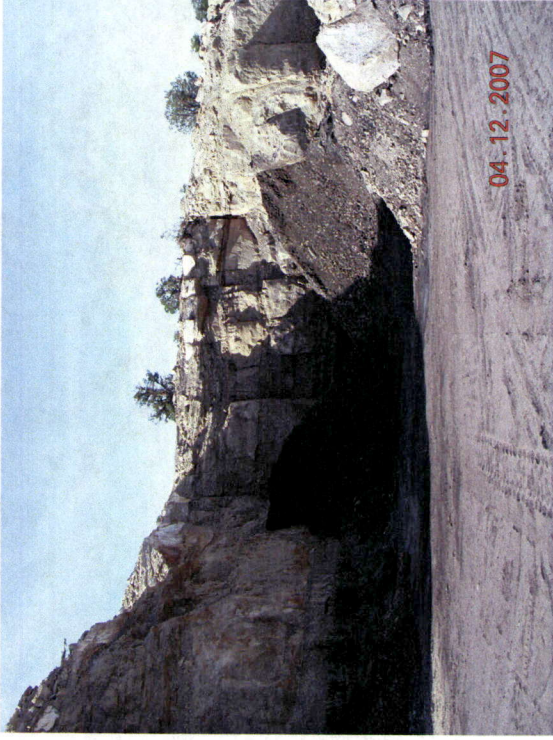
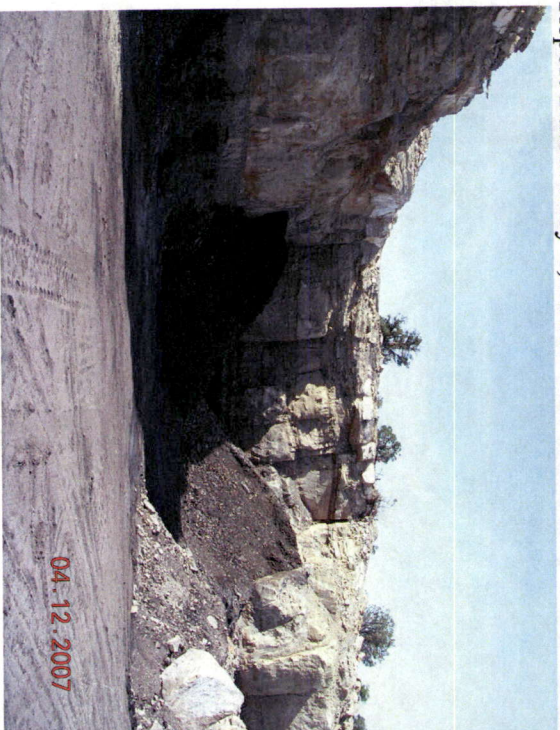
**Photo 3. This is an area on the northwest side of the mine that was developed a few years ago.**

Photo 3. This is an area on the northwest side of the mine that was developed a few years ago.

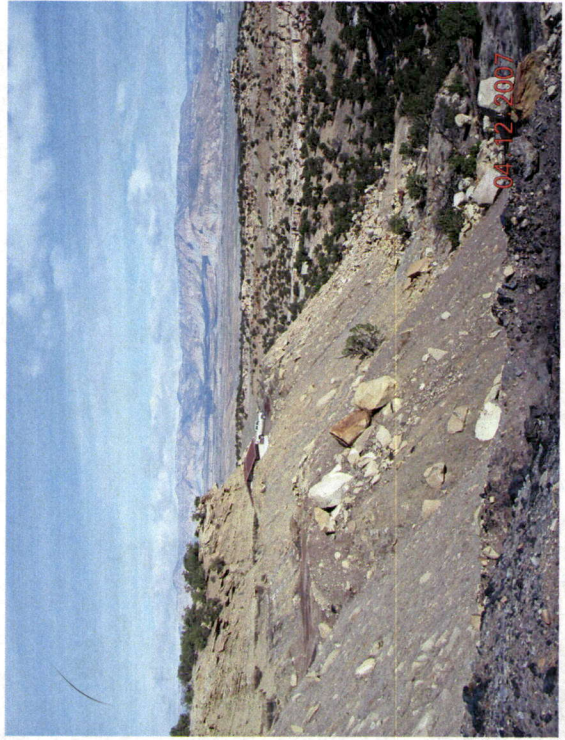
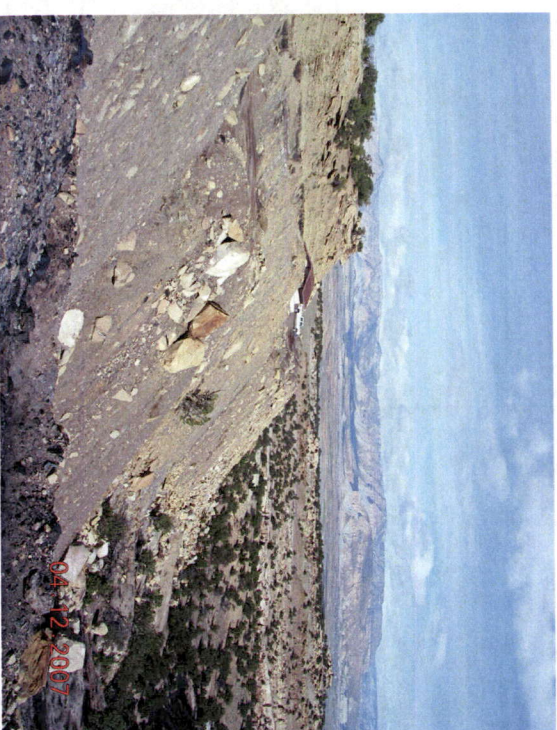
**Photo 4. The outslope of the mine.**

Photo 4. The outslope of the mine.
